# **Closure Report**

Interim Repair Action OU A Charleston Beach

# **Bremerton Naval Complex**

Bremerton, Washington

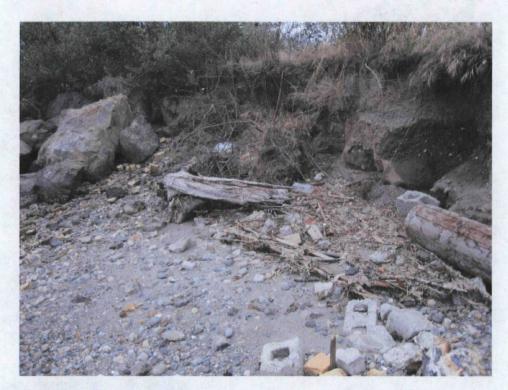
Looking at southwestern corner of bluff, 30 July 2007.

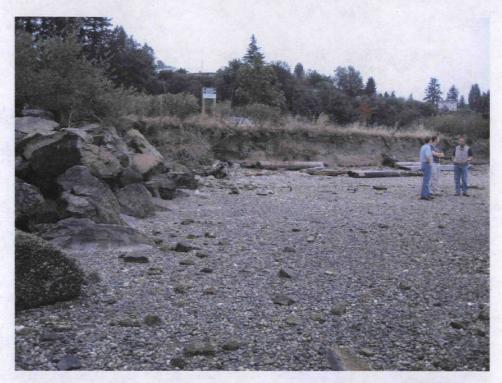
Looking east at embankment gauge, 30 July 2007.

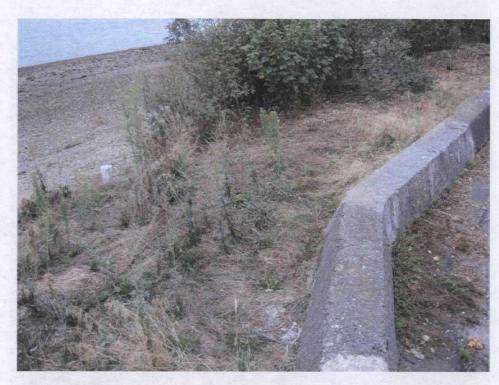
Looking down at embankment gauge, 30 July 2007.

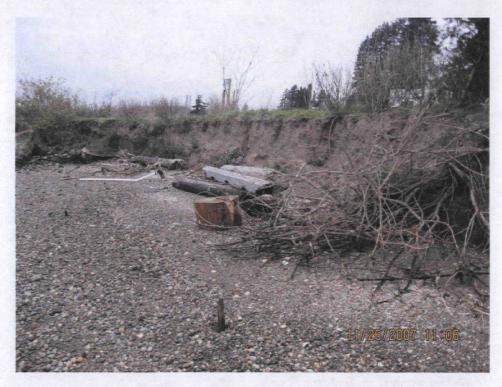
Looking at west side of bluff with wood debris on beach, 26 November 2007.

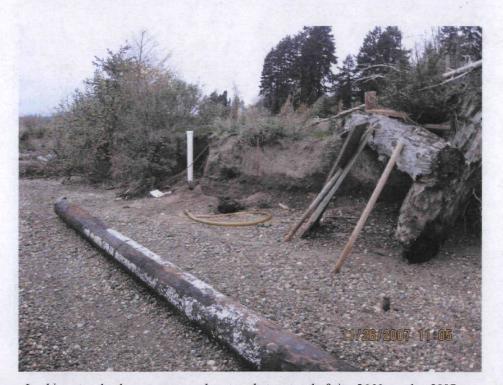
Looking at embankment gauge and root wad at east end of site, 26 November 2007.

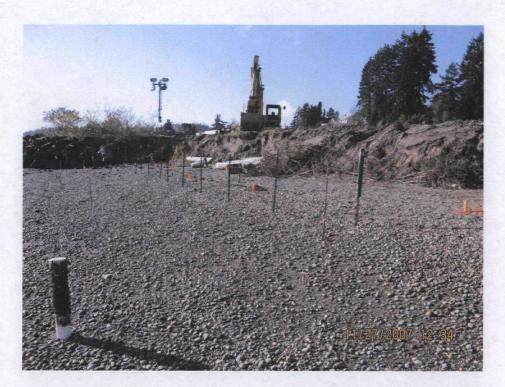
Looking southwest at debris on beach with beach erosion gauge visible, 27 November 2007.

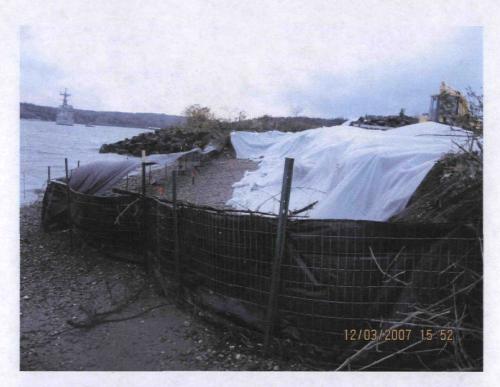
Damaged silt fence from storm, 3 December 2007.

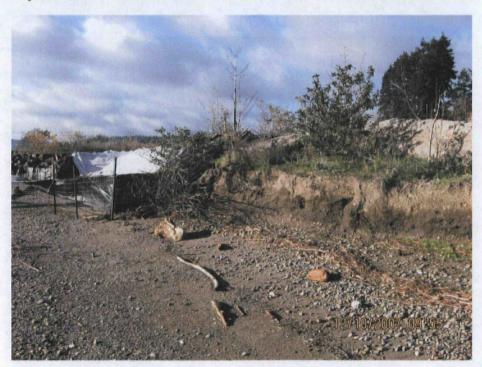
Silt fence damage and bluff at east end of project site, 10 December 2007.

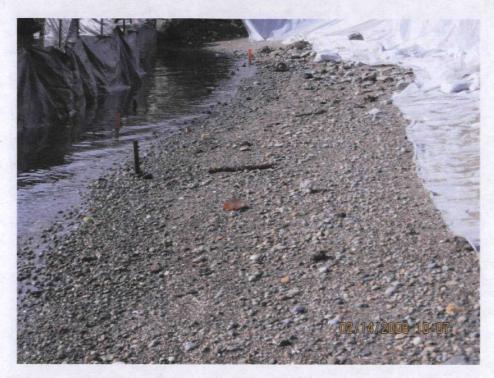
Debris becoming visible on beach, 24 January 2008.

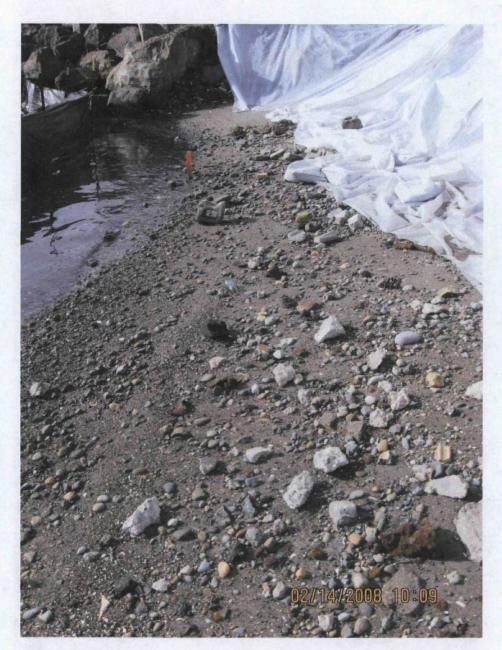
Debris becoming visible on beach in southwest corner, 14 February 2008.

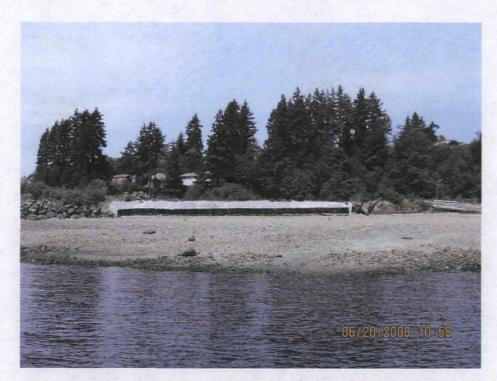
Looking at face of shoreline, 20 June 2008.

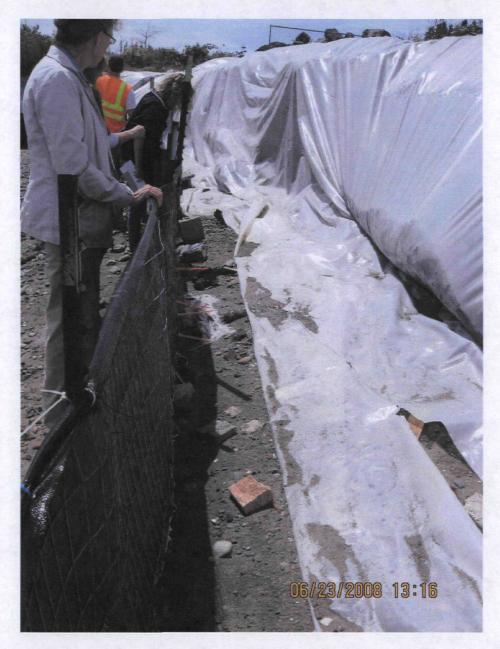
Shoreline sloughing contained by plastic sheeting, 23 June 2008.

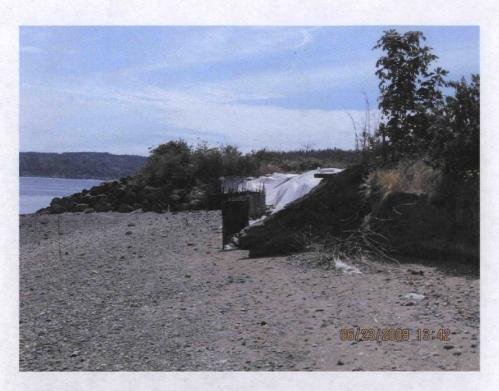
Looking west at silt fence and eroding bluff at east end of site, 23 June 2008.

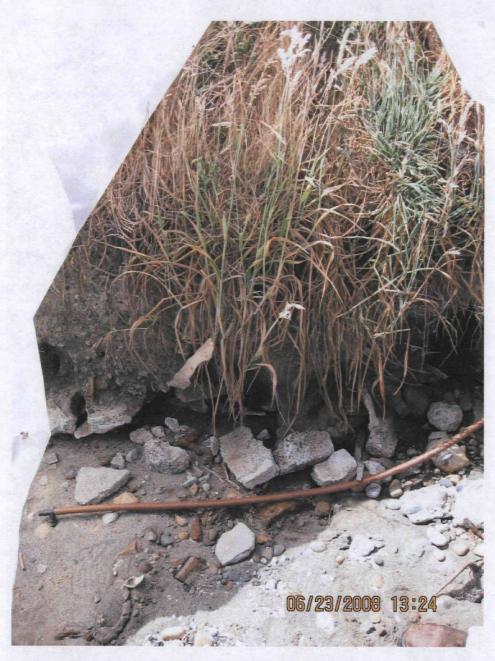
Undermining of bluff at east end of site, 23 June 2008.

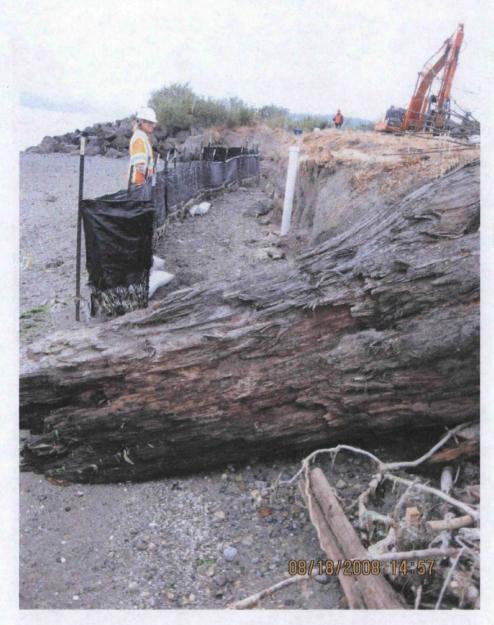
Looking west along toe of eroded bluff, 18 August 2008.
